**EXPANDED SITE INSPECTION REPORT
FOR THE
BENDIX AUTOLITE CORPORATION SITE
(A.K.A. ALLIED SIGNAL)
FOSTORIA, OHIO**

**EXPANDED SITE INSPECTION REPORT
FOR
BENDIX AUTOLITE CORPORATION
1600 NORTH UNION ROAD
FOSTORIA, OHIO**

U.S. EPA Work Assignment No.	:	36-5JZZ
U.S. EPA Region	:	5
Date Prepared	:	February 6, 1996
Contract No.	:	68-W8-0084
PRC Project No.	:	030-0036535
Prepared by	:	PRC Environmental Management, Inc. (Gabriel Rood)
PRC Project Manager	:	Gabriel Rood
Telephone No.	:	(513) 241-0149
U.S. EPA Work Assignment Manager	:	Jeanne Griffin
Telephone No.	:	(312) 886-3007

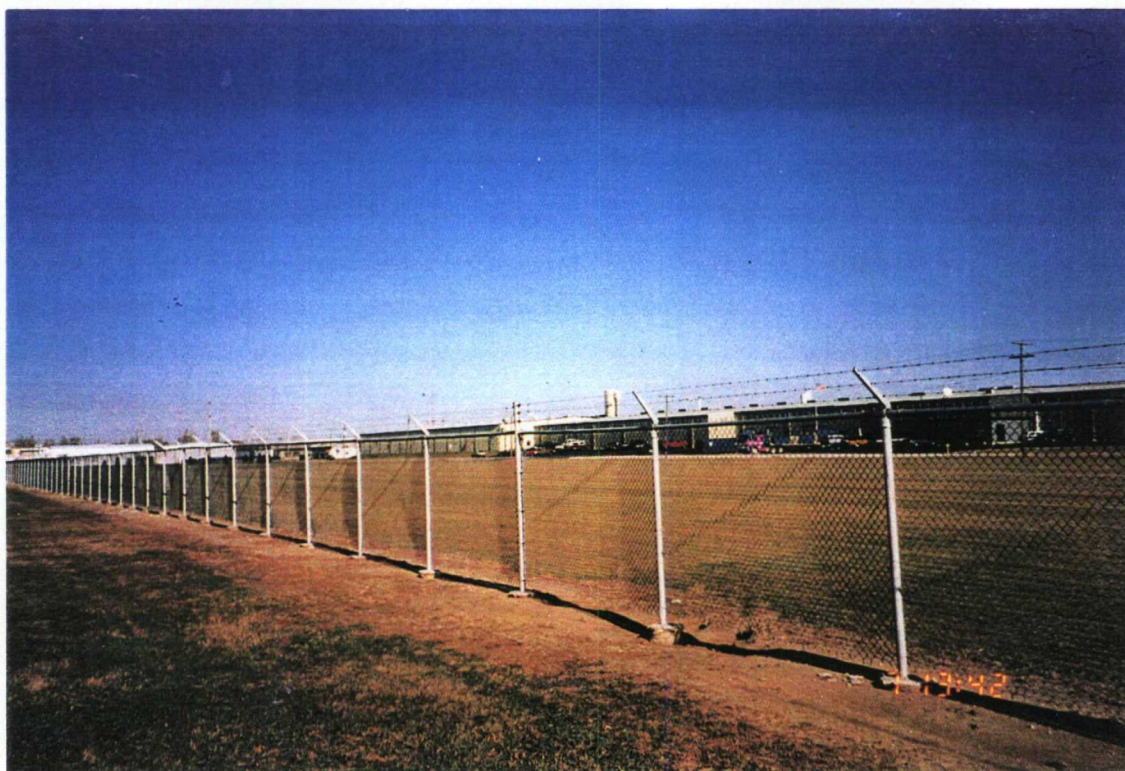
Photograph No. 1
Orientation: Northeast
Description: Fenceline along east side of site; IDI is visible in background

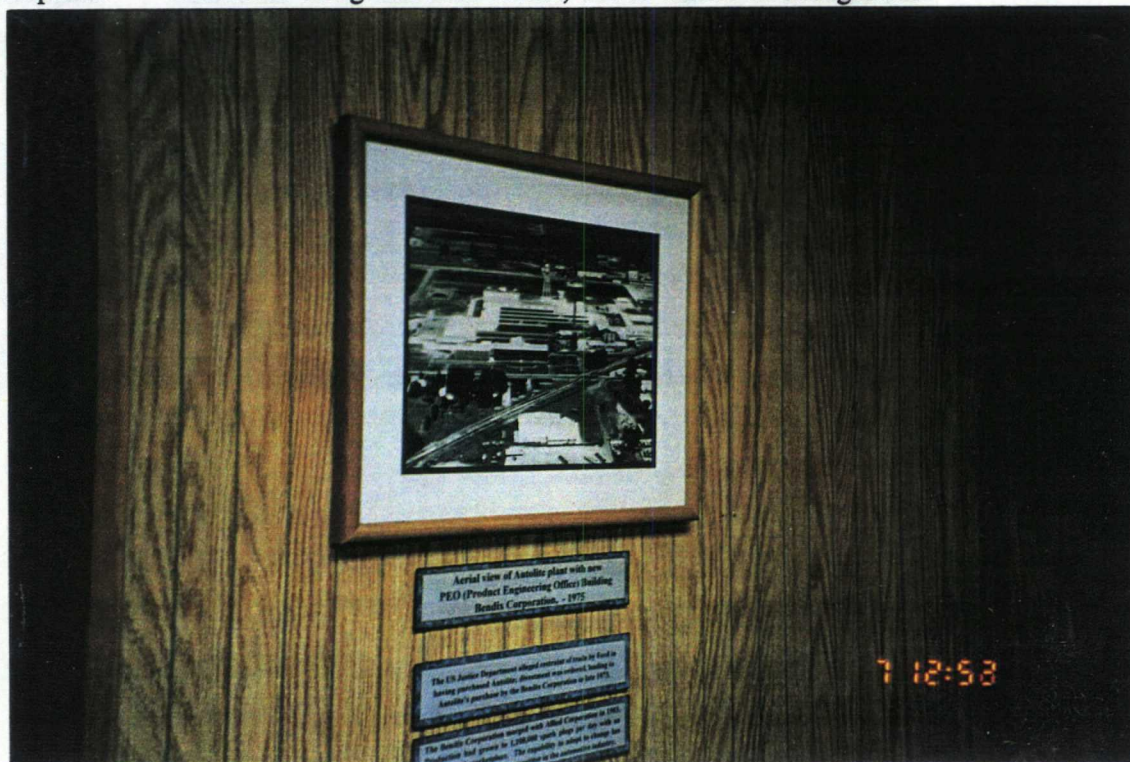
The manufacturing area consists of original site buildings to which several modern additions have been added (see Photograph Nos. 2 and 3). The administrative offices and the product engineering research and development department are located in the westernmost building, along North Union Street. The remainder of the area consists of large open buildings that house spark plug and oxygen sensor manufacturing and warehouse operations. The current storage building for hazardous waste drums (see Photograph No. 4) is located on the east side of the facility adjacent to the shipping and receiving dock. An older storage building for hazardous waste drums is located about 100 feet south of the current one (see Figure 2).

Photograph No. 2
Orientation: N/A
Description: Aerial view of the Bendix facility in 1975

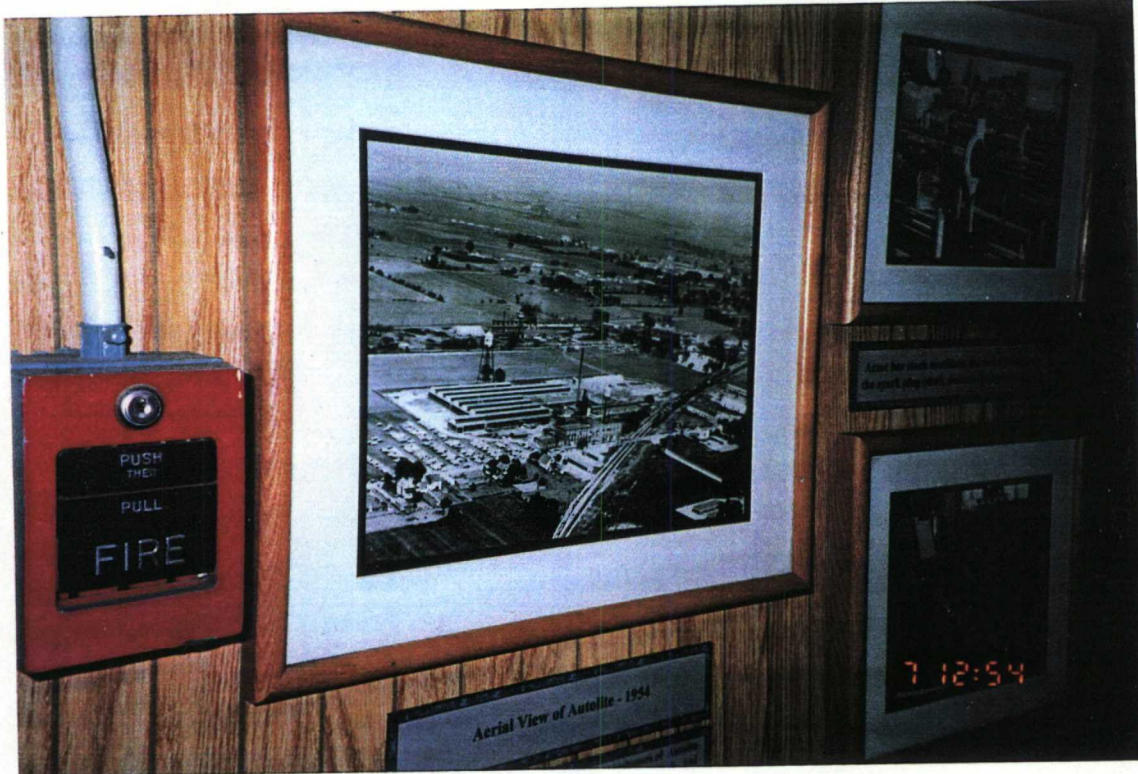
Photograph No. 3
 Orientation: N/A
 Description: Aerial view of the Bendix facility in 1954

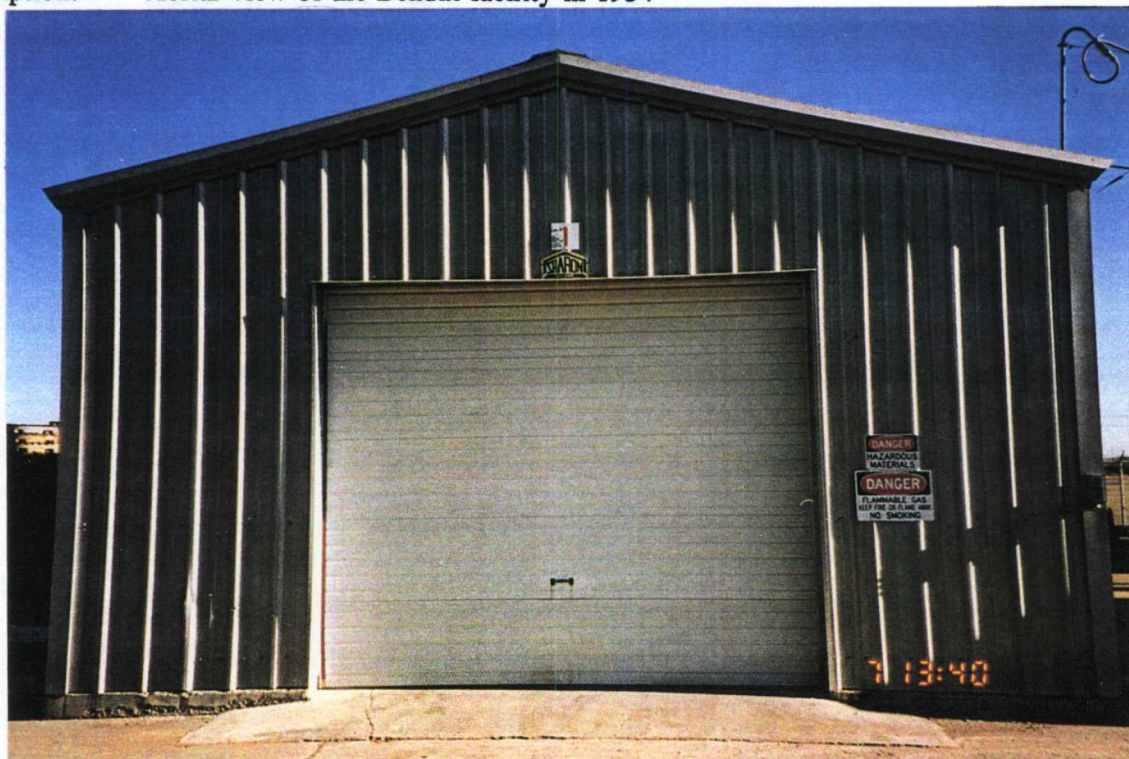
Photograph No. 4
 Orientation: East
 Description: View of the current hazardous waste drum storage building

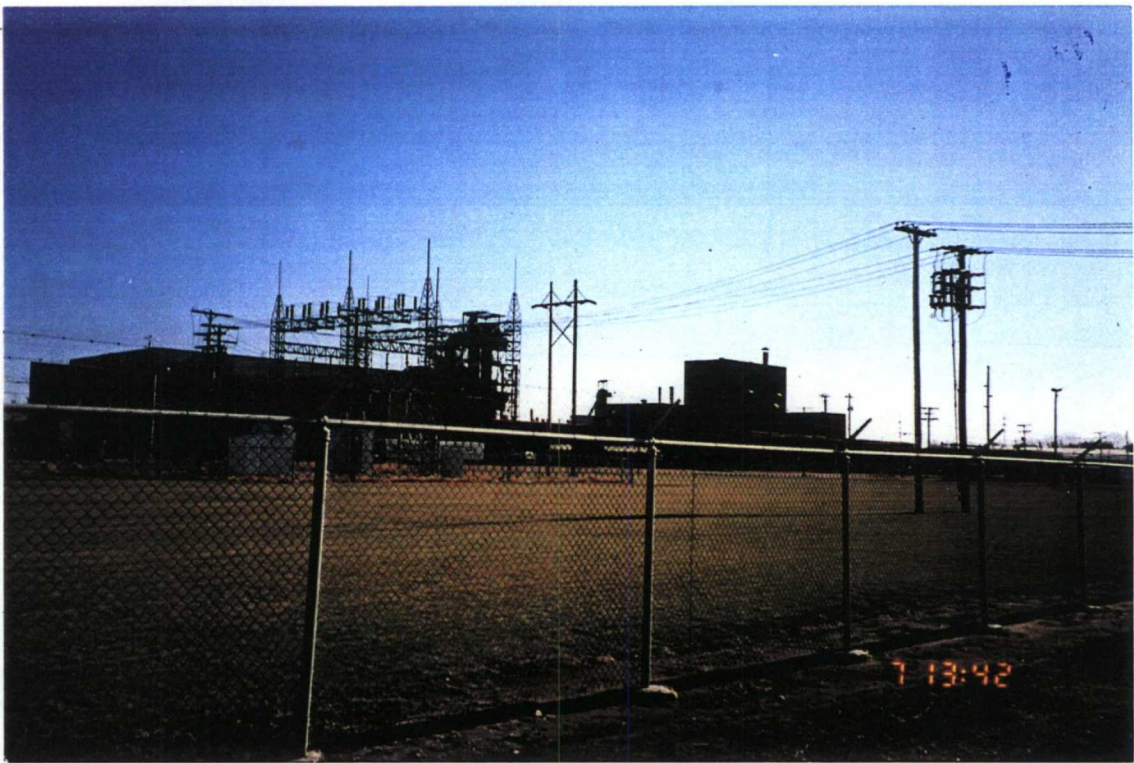
Photograph No. 5

Description: View of fenceline, electrical substation, and former Chrysler foundry

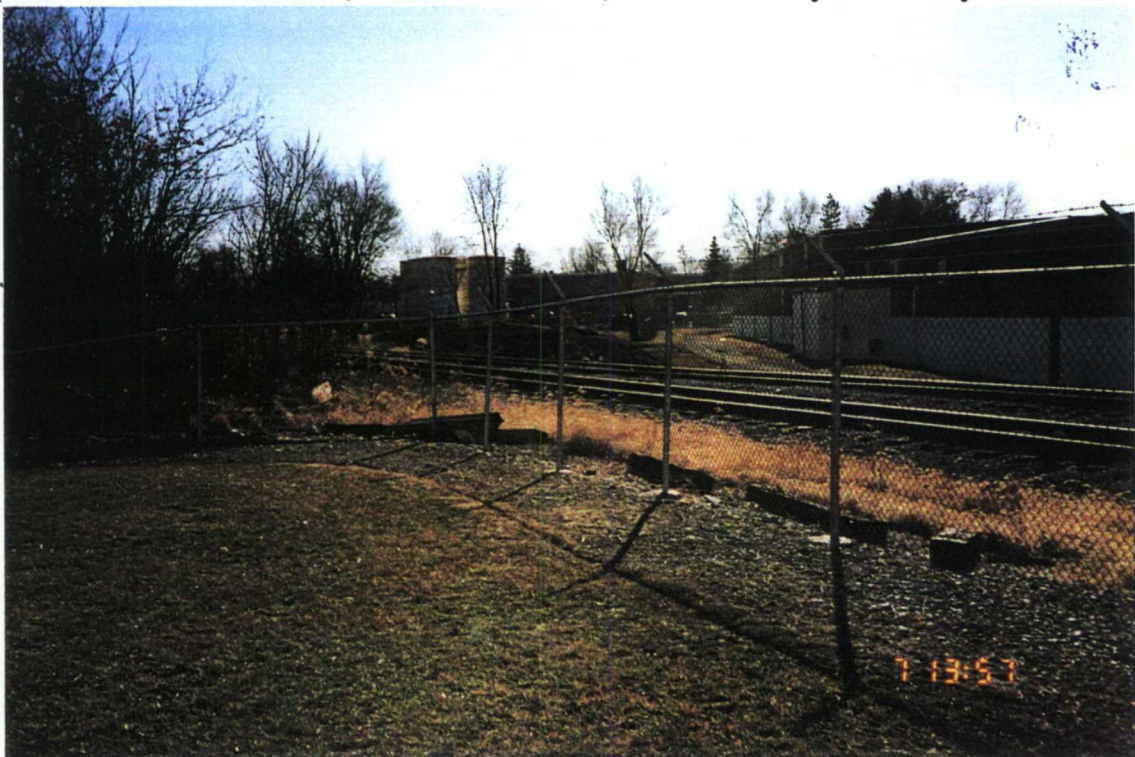
Photograph No. 6

Description: View of RRC building, railroad tracks, Bendix fence, and the transfer station tanks for the former Pearl Oil

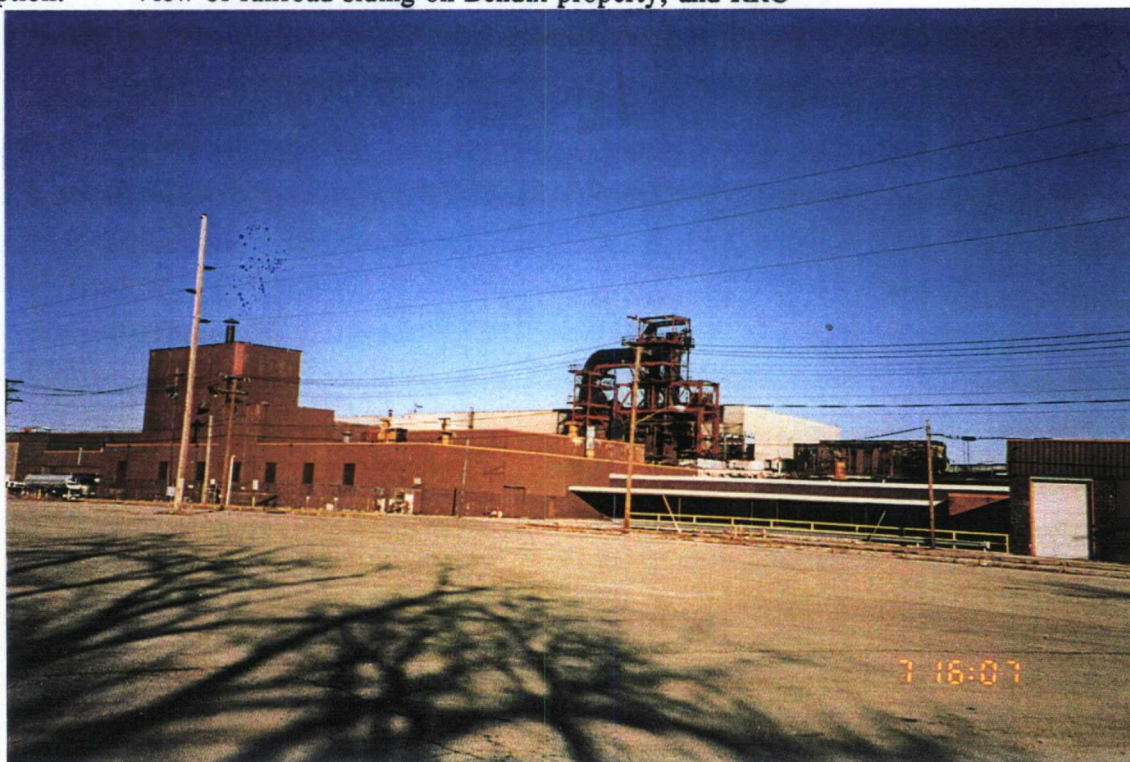
Photograph No. 8

Description: View of former Chrysler foundry

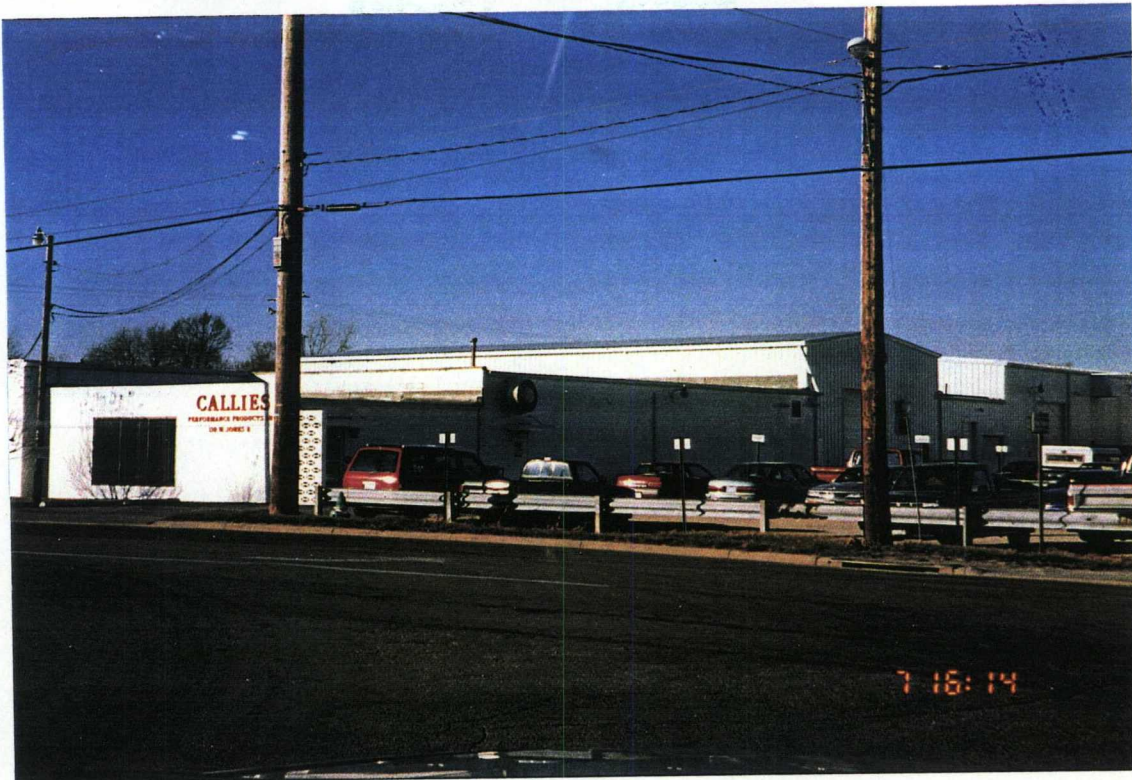
Photograph No. 9

Description: View of industry located north to northeast of the Bendix site

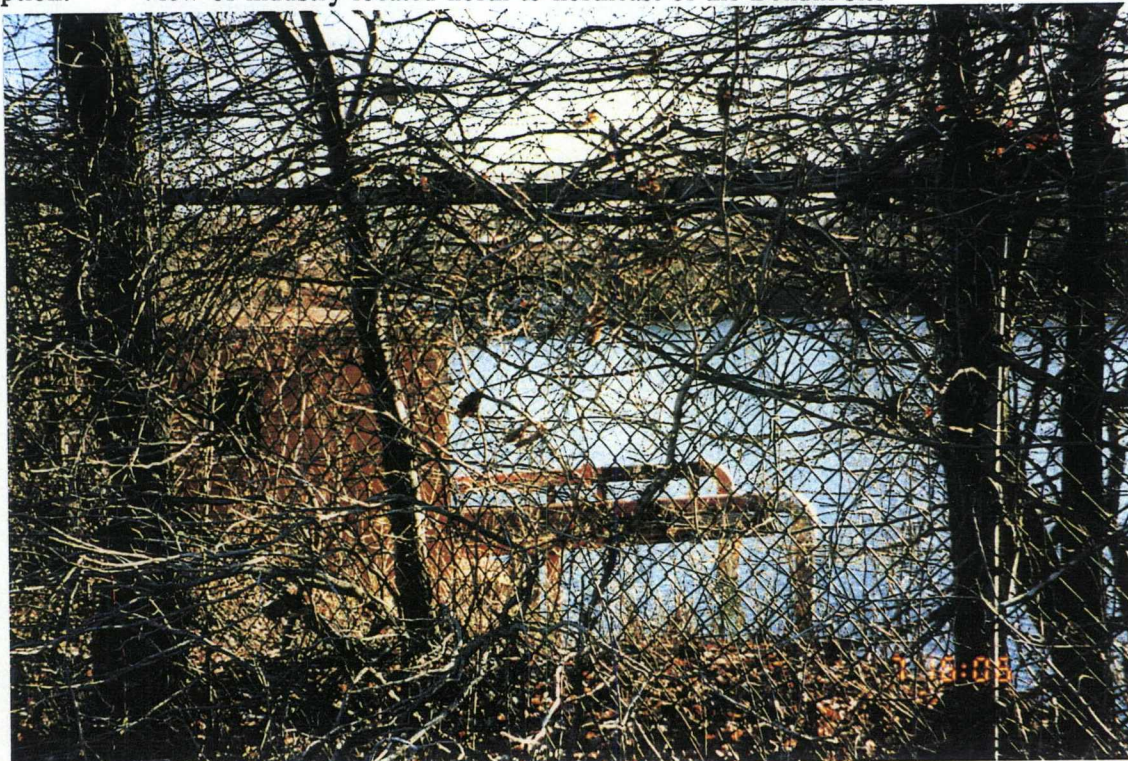
Photograph No. 10

Description: View of pumphouse and quarry pond

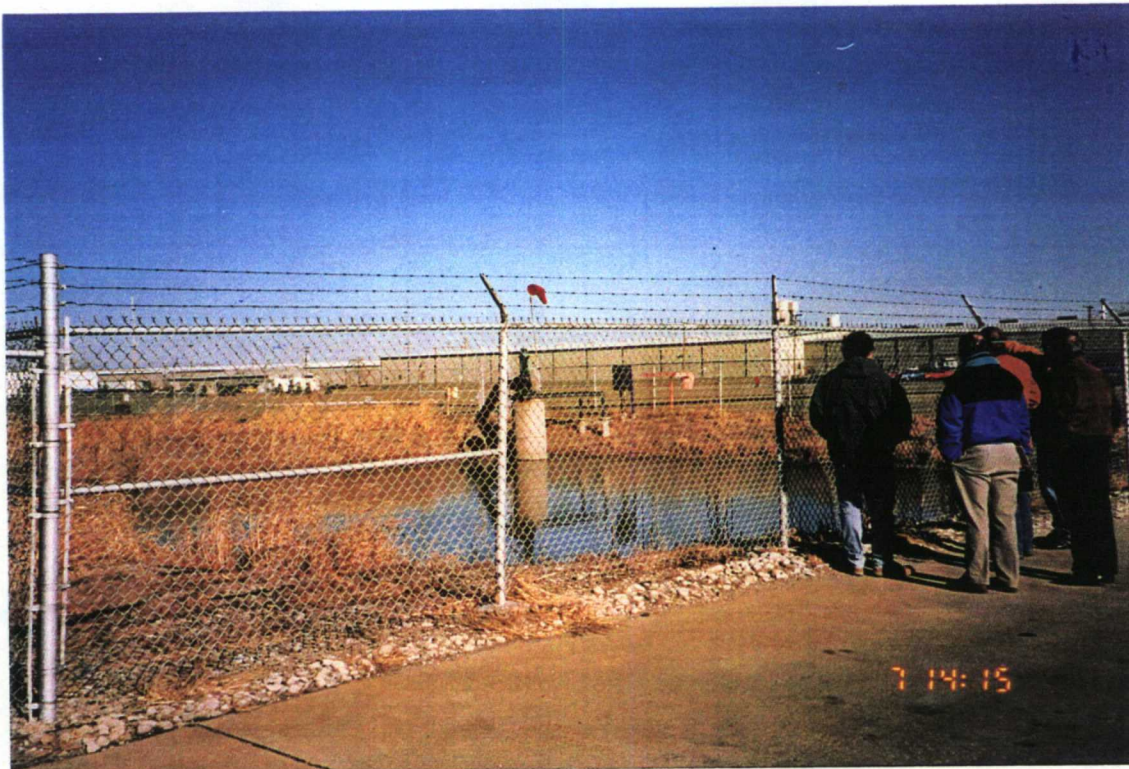
Photograph No. 11

pond is located at the northeast corner of the site (see Photograph No. 11). A large drain pipe is located in the northeast corner of the pond. Water released to the drain pipe flows through a buried drain pipe to an unnamed intermittent drainage ditch located east of the site (see Figure 3). A rail siding and railroad tracks serve the southwest side of the site and nearby industries (see Photograph No. 12).

Description: Storm water retention pond; drain pipe is located where surface water from pond discharged to the former ditch that drained to North Main Street

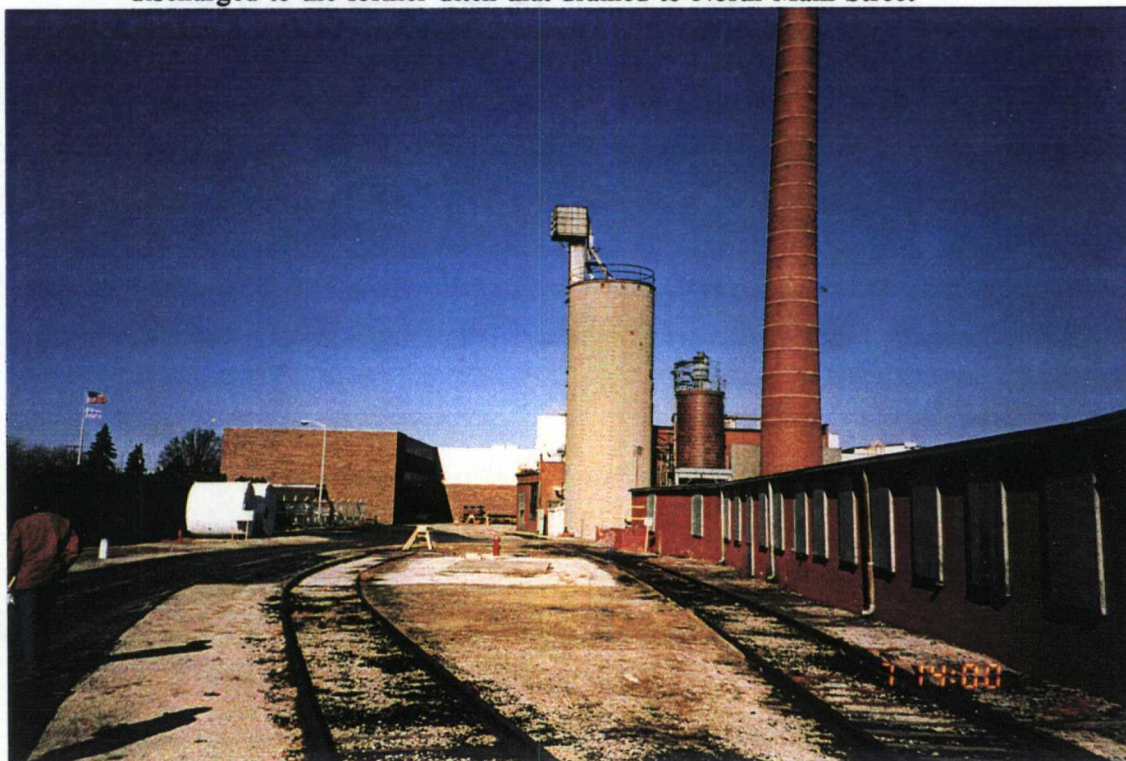
Photograph No. 12

Description: View of former power house, railroad siding, and administration building

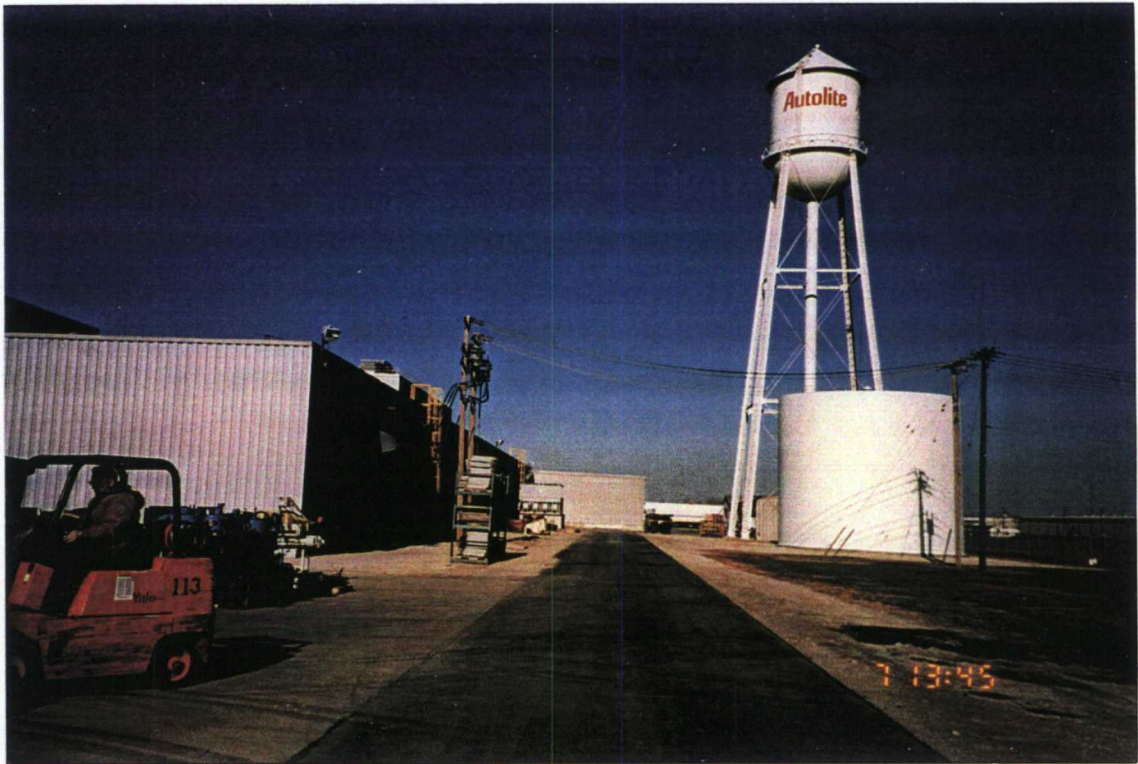
Several potential sources of chlorinated solvents were formerly located at the rear or east side of the site (see Photograph No. 13 and Figure 3). A hazardous waste drum storage area, a TCE storage tank, and an indoor TCE degreaser unit were located in this area. Another former degreaser unit, two buried tanks, and a waste storage tank were located on the western side of the manufacturing facility (see Figure 3).

Photograph No. 13
Orientation: North
Description: View of area where TCE was formerly stored
